Some notes on a pond at Brislington Meadows

Ken Taylor (2023)

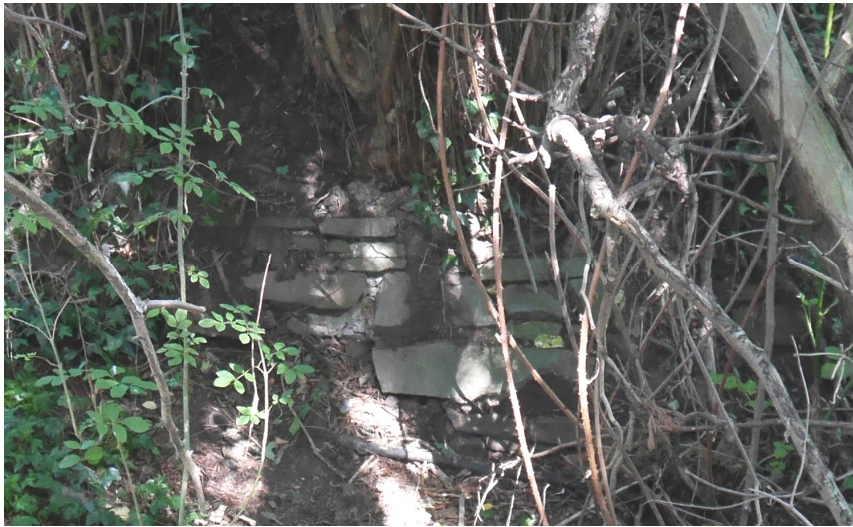
Masonry survives intact in the northeast wall, and south corner. Both areas are of grey Pennant sandstone, which is the local bedrock, and of rubble construction (which is simply to say the stones haven't been shaped into neat blocks of regular size and shape). The individual stones are bonded with a hard white mortar that contains many granules of angular black material (occasionally up to ten millimetres across) resembling cinders.

Surviving masonry in the northeast wall.

The northeast wall is set into an earth bank that would have been created in digging the pond into the field's natural slope (or, perhaps a lynchet riser). This bank rises some 1.2m above the modern ground level, and the surviving stonework rises to around half that height and extends to at least 2.83m across. This wall leans back into the back at an angle from vertical of around 30 degrees, which may have been deemed sufficient to face the slope with stone and retain the soil.

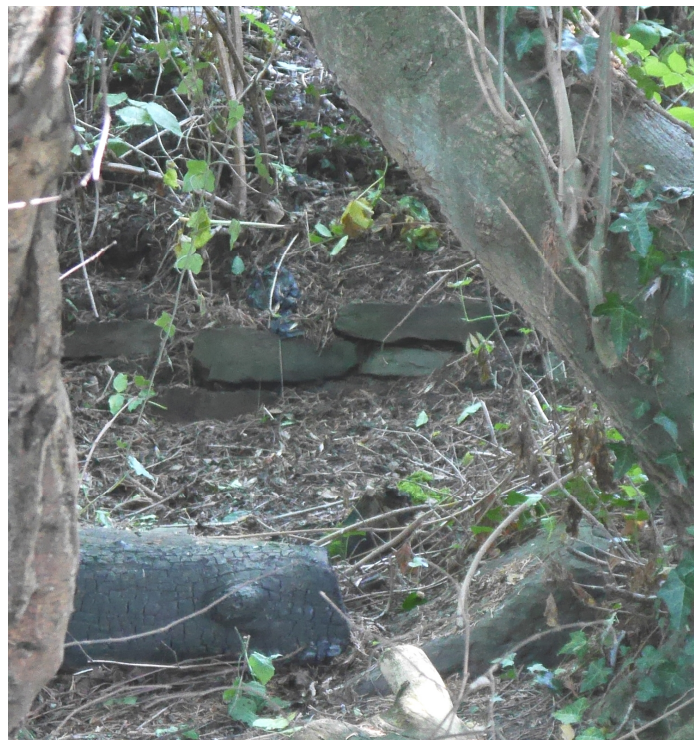
Surviving masonry in the southeast wall
(with a large, squared stone in the foreground).

The masonry of the south corner extends at least 1.33m along the southeast wall, where courses achieve some 0.5m in height; and at least 0.48m along the southwest wall, where courses are some 0.3m high. The thickness of the southwest wall was found (judging by its uppermost stone) to be 0.4m (16 inches).

The enclosed area contained some loose stones, as would be expected from its collapsing walls, but one stone was exceptional. It's partially buried but the exposed piece measured 0.62m long by 0.41m wide and 0.15m deep. The only complete measurement was the width which, in Imperial units is 16 inches. This stone was apparently painstakingly shaped to be a roughly rectangular block, with right angles in three dimensions at its corners, and straight parallel edges. Its purpose is open to conjecture. Its width, being identical with the measured width of one of the walls, permits interpretation as a coping stone. Such professionalism represents a significant investment of money in the design and building of this structure.
