Brislington Community Museum News

2025 July

Boundary wall of Mount Pleasant

These notes concern a stretch of wall that appears to have formed a boundary to the private dwelling house originally known as Mount Pleasant (currently Arnos Manor Hotel, and once the Arno's Court Roman Catholic convent), Brislington, Bristol.

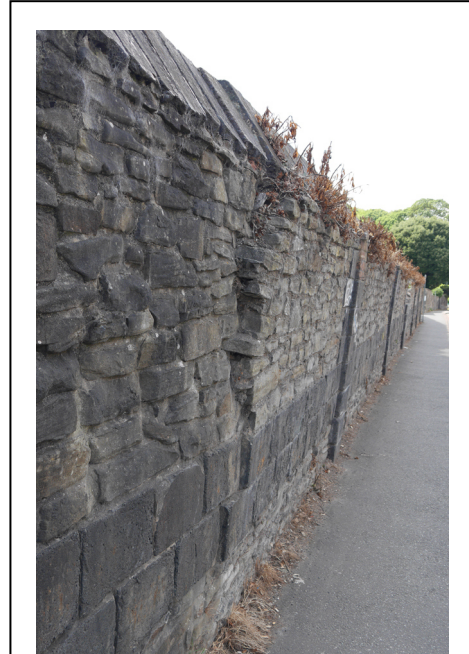
Portion of the wall to the left (east) rebuilt to make it more vertical (photo 7 July 2025).

A screen wall is constructed to bear only its own weight, whereas a retaining wall needs to be much stronger. The wall's tendency to bow out away from the cemetery has been addressed on at least one occasion (evidenced by the rebuilt portion illustrated on page 1).

Panel 1, pilaster 1, and almost half of panel 2 appear to be a reconstruction that has re-used the slag blocks and preserved the general appearance of the original structure (without the precision). This section is more upright than much of the rest of the wall, suggesting the rebuild may have been required to make a slumping wall safe.

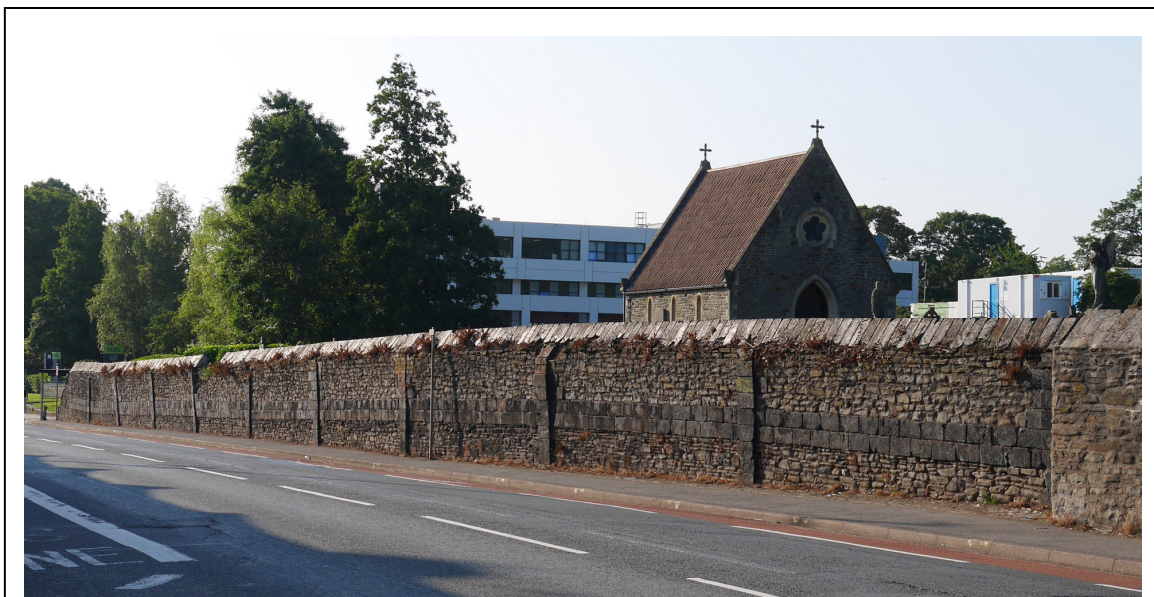
Looking east-southeast at the whole of the surviving wall (photo 19 June 2025).

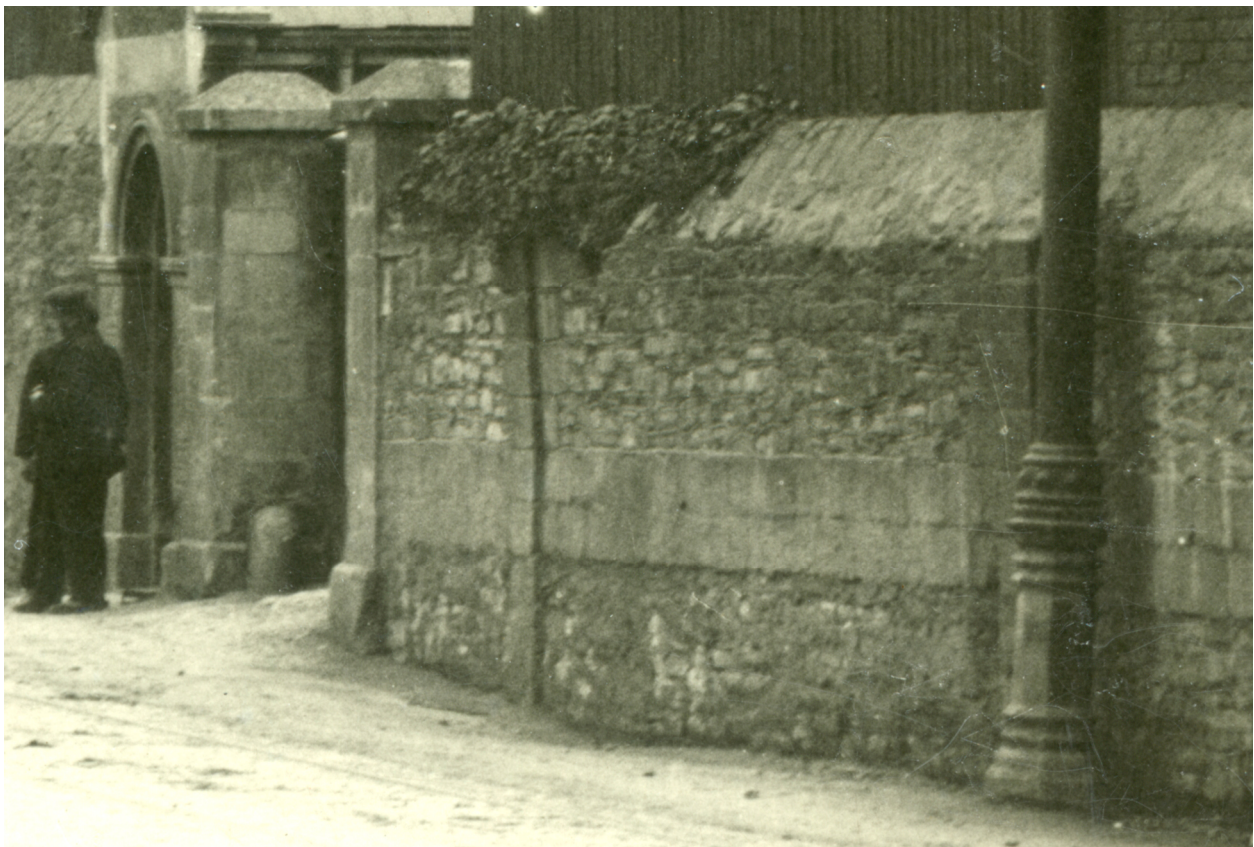
Convent entrance. Detail of postcard by Fred Viner published in or around 1916 (reproduced with the kind permission of Jonathan Rowe, chairman of Brislington Conservation and History Society, from a postcard in their collection).

One postcard published on the website of Bristol Archives clearly shows both the double row of rectangular blocks and the sloping coping blocks on both sides of the convent's entrance (Anon c.1908). Other postcards establish there was also at least one pilaster to the east of the entrance (Westfield c.1930), and two to the west (Viner & Co c.1916) - all of the same type as those surviving in the wall today.

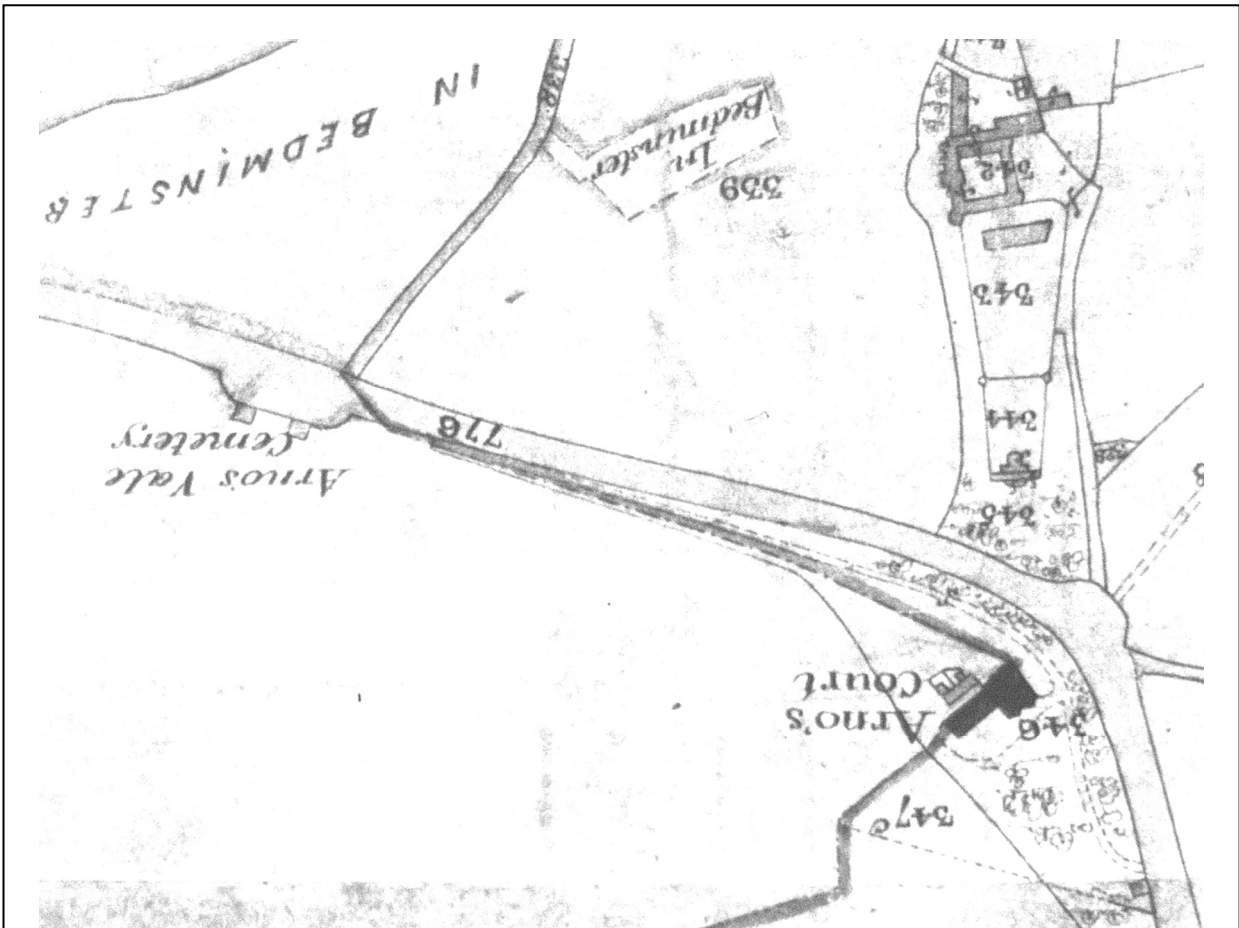
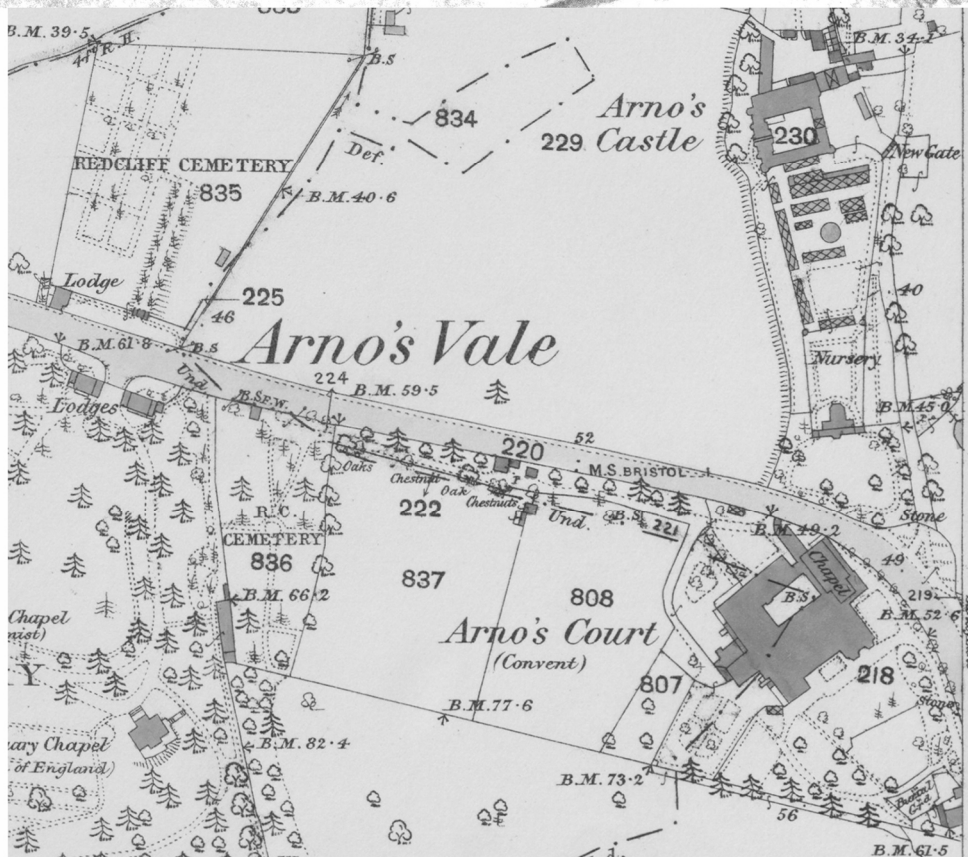
The 1844 Tithe map (upper) which appears to have its lettering upside down, but simply predates the convention of having north at the top, and the 1886 Ordnance Survey map (lower).

The 1st edition Ordnance Survey map on the Know Your Place website is slightly misaligned to the Bristol City Council 'Basemap' (Bristol City Council 2019) at this location. When that OS map, which was surveyed in 1883 (OS 1886), is fine-tuned in relation to the Basemap, it shows the boundary between the house that William Reeve built - originally Mount Pleasant but marked on the map as "Arno's Court (Convent)" - and the Bath Road was precisely in the position of the wall of current interest.

Almost forty years earlier than that OS map, and nearly a decade before the house became a convent, a tithe map (Brown & Sturge 1844) shows that inside the grounds of Arno's Court, a driveway ran roughly parallel with the Bath Road, along the back of the wall. This drive provided rear access to the property.

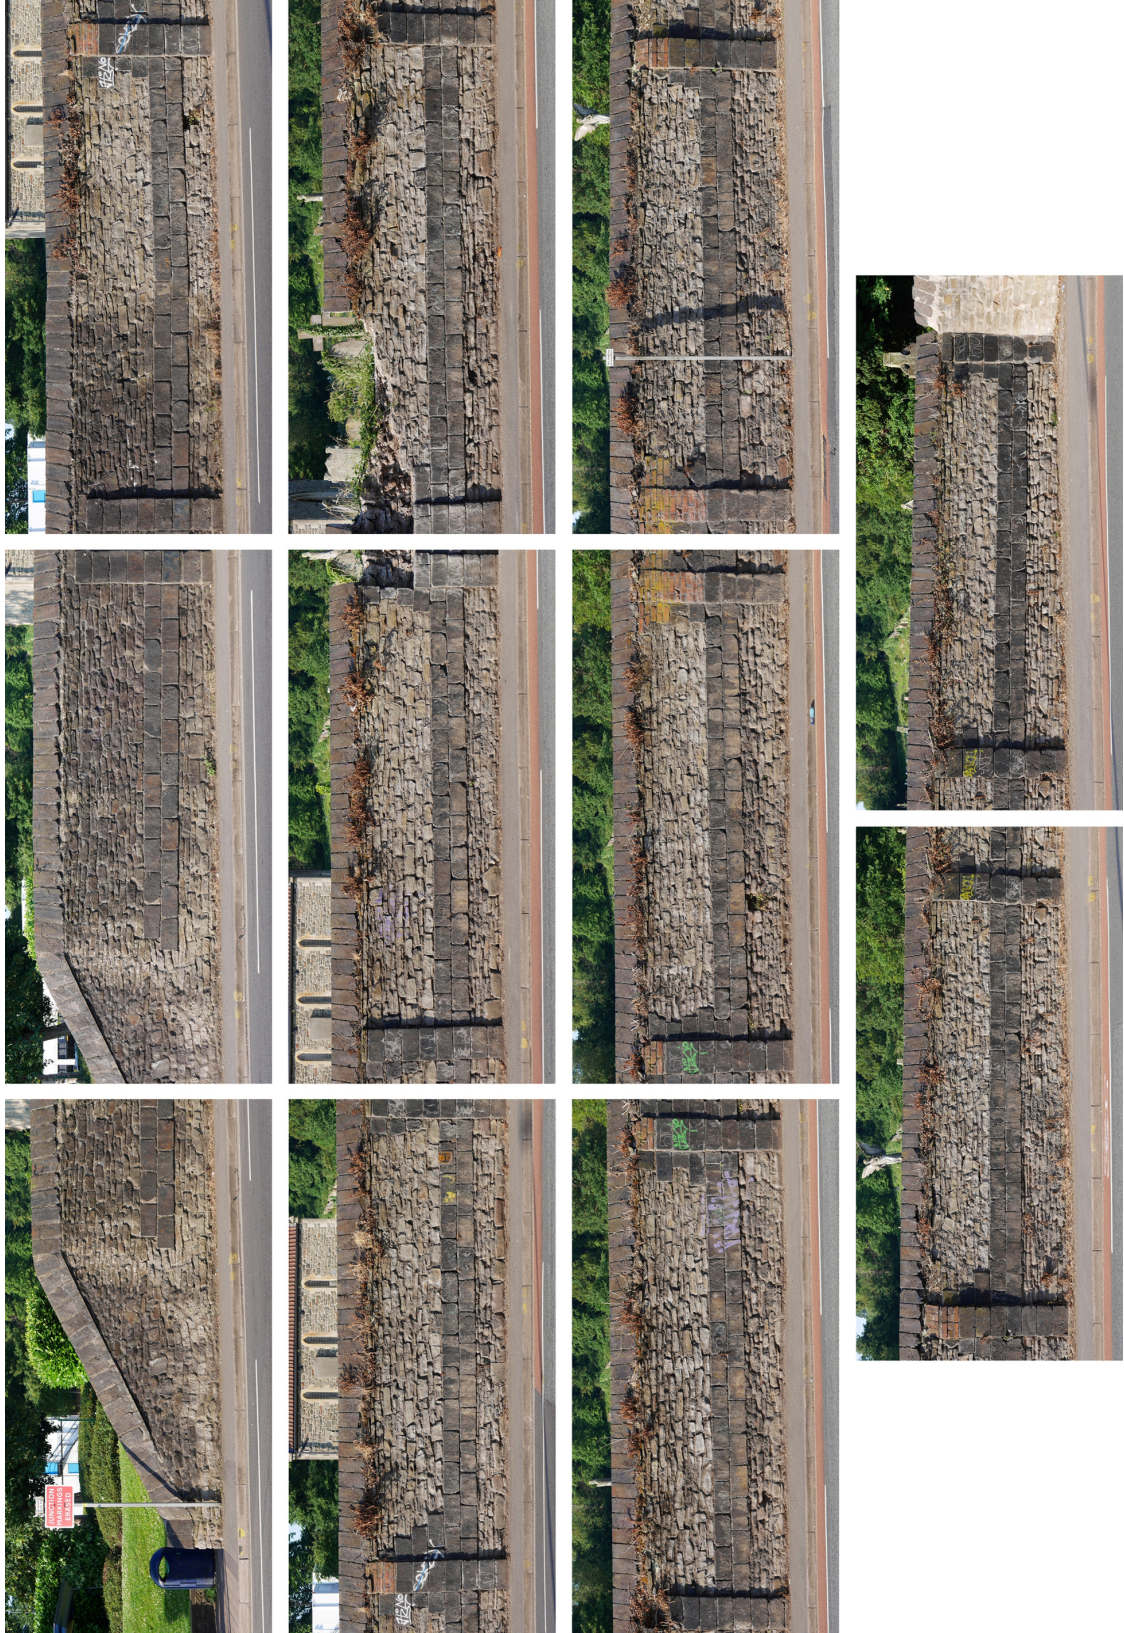
The front of the surviving wall. The first photograph being of the wall's left-hand (east) end, such that panel 10 and pilaster 10 are in the last picture (photos 19 June 2025).

Three pilasters (numbers 3, 9 and 10) appear to be in their original form and complete (pilaster 3 is topped by a single block of pennant type stone, and the other two are each topped by a block of slag laid on its face to reduce its height).

The others pilasters all appear to have received repair in their upper part. Pilasters 2, 4, 6, 7 and 8 have bricks inserted under the coping to replace

one or more blocks of slag, pilaster 5 is damaged and its original composition and infill (if any) is unknown. Pilaster 1 may have been rebuilt.

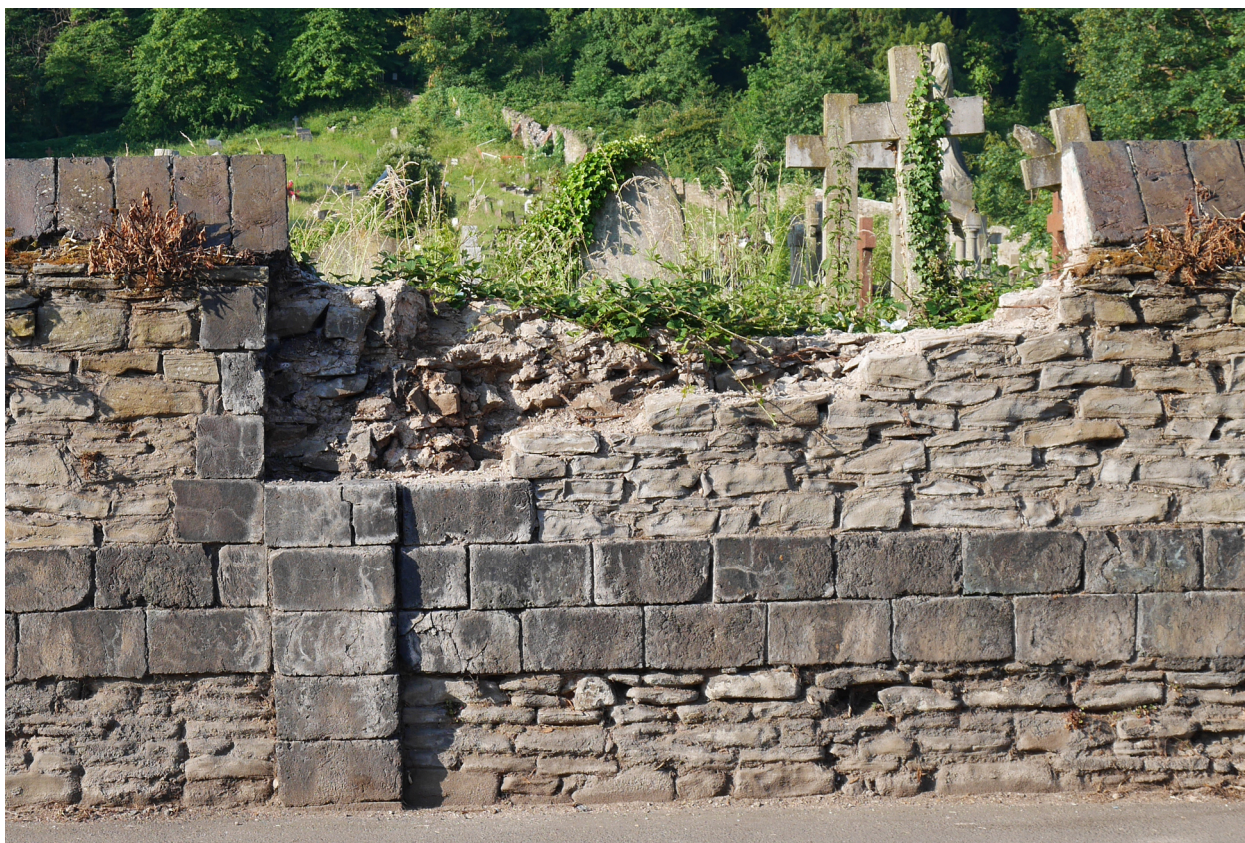
A few stones fell in January 2025, and a substantial part was then dismantled (photo 19 June 2025).

It's tempting to assume a recent fall of stones may also be a symptom of such structural stress, but that would be mere conjecture.

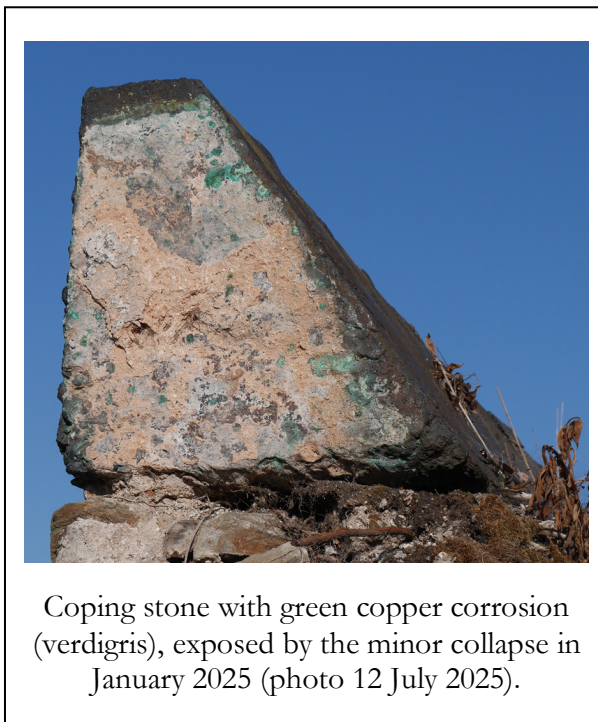
Coping stone with green copper corrosion (verdigris), exposed by the minor collapse in January 2025 (photo 12 July 2025).

The top of the wall has coping of blocks of copper slag which are taller than they are wide. Their broad side is a trapezium, where three sides meet at right angles (base, back, and top platform), and the fourth is a slope that rises from the base of the front toward the back at an angle calculated to be approximately 56°.

The base of the block sits across the full thickness of the top of the wall, so the wall is 15 inches (381mm) deep at the top. The back of the block rises vertically. At the top of the back is a projection toward the front that makes a level platform parallel with the base. The fourth side is the slope connecting the platform at the top back, with the base at the front.

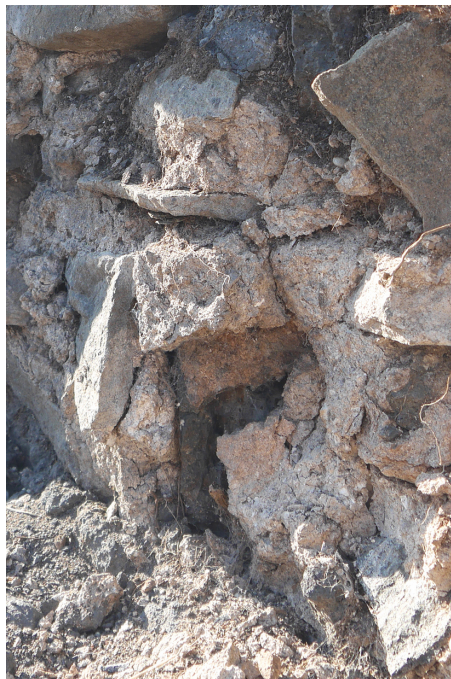
Mortar exposed by the demolition after the minor collapse in January 2025 (photo 12 July 2025).

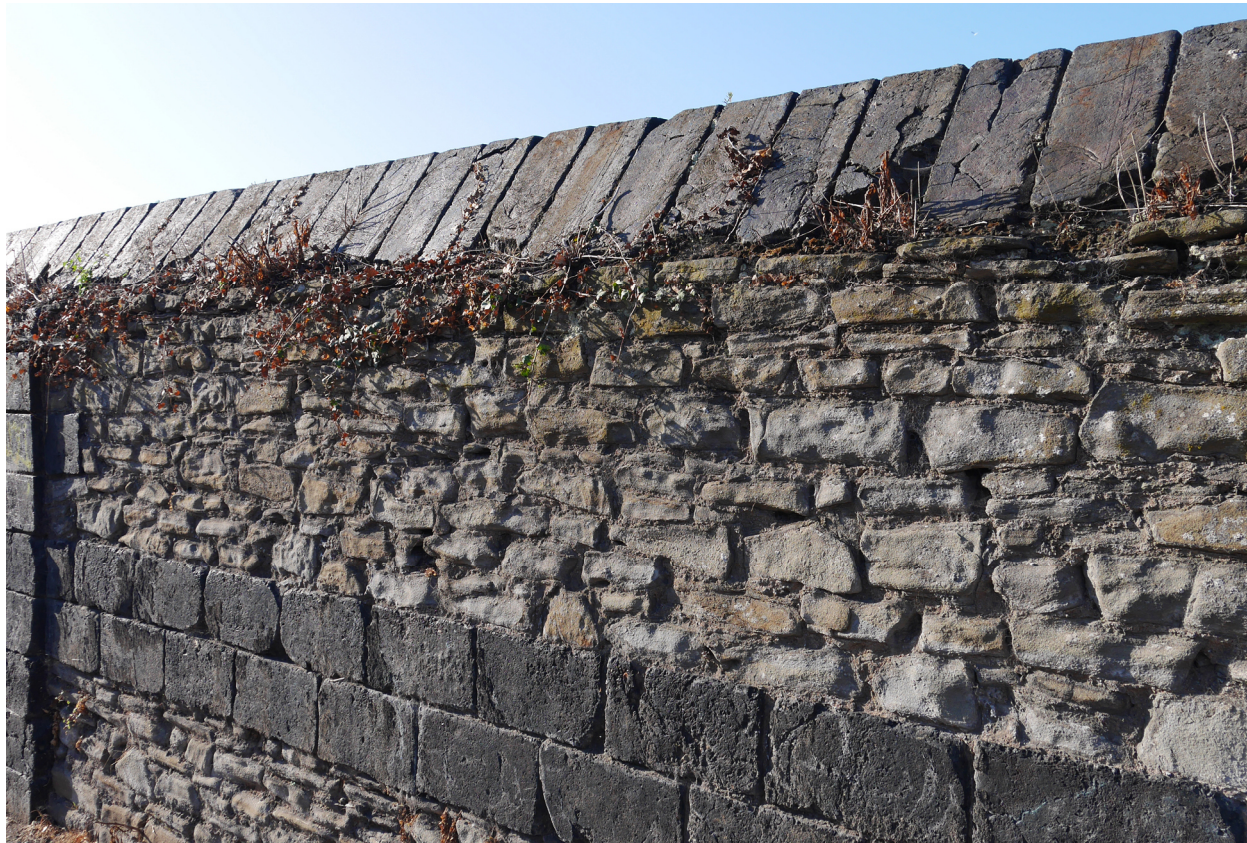
The smooth top line of the wall is illustrated here with panel 10 (photo 12 July 2025).

the top edge forms an apparently smooth line (this line gently rises and falls more or less in parallel with the double row of blocks). This was achieved not only the conventional use of thin slabs of pennant stone, but the insertion of much finer sheets of slate.

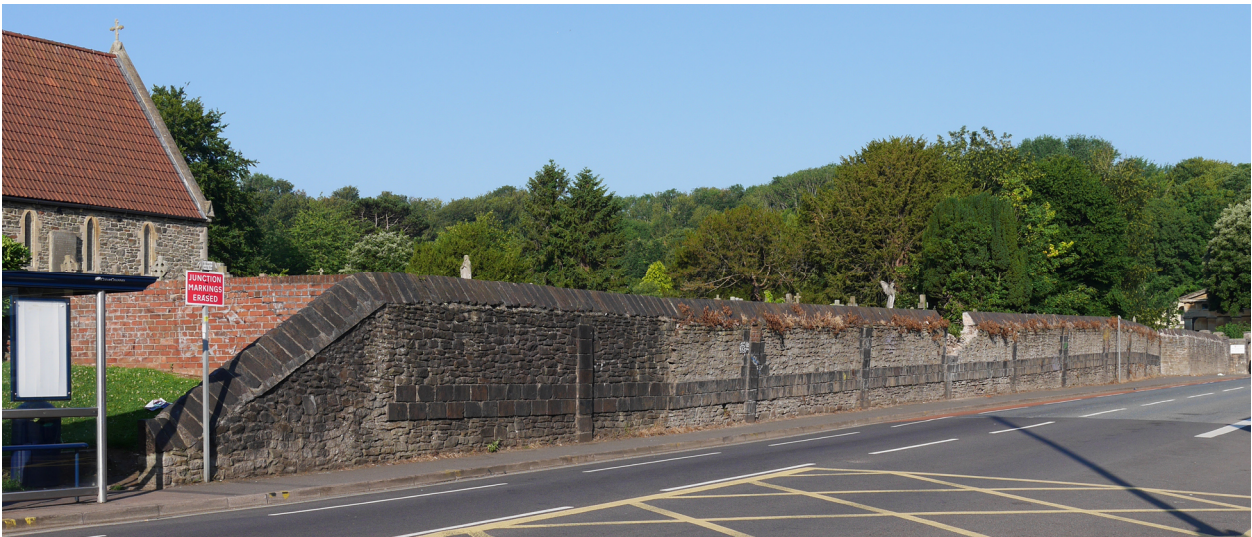
Looking west at the whole of the surviving wall (photo 19 June 2025).
