# Brislington Community Museum News

2026 February

## St Luke's shards

# Casualties of war

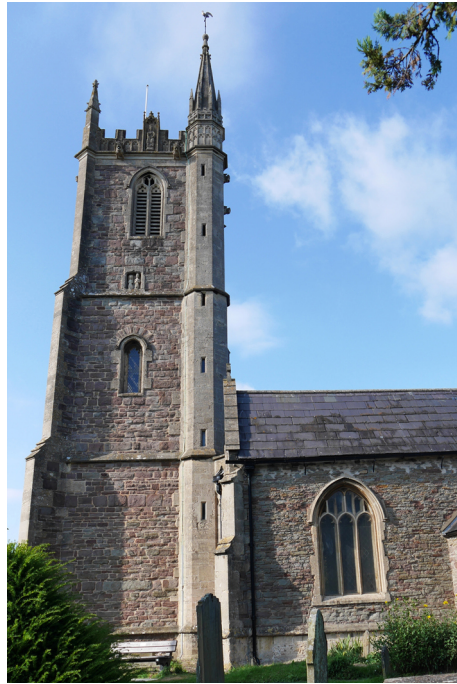
The spirelet (with weather vane) was rebuilt after being struck by lightning. When the damage was photographed in 1919, some pictures captured glimpses of the stained glass windows.

In 1919, on 24 December, lightning struck the church tower causing the miniature spire at the southeast corner to fall. This spirelet was larger than the pinnacles at the other corners as it gave access to the roof from the stair turret.

Local photographer William Winchester, who had a well-established studio in Langton Road, St Anne's, recorded the damage in a series of pictures. Although the windows weren't directly affected, and so weren't specifically documented, parts of both the west end and the south side of the south aisle were incidentally captured in this valuable historical record.

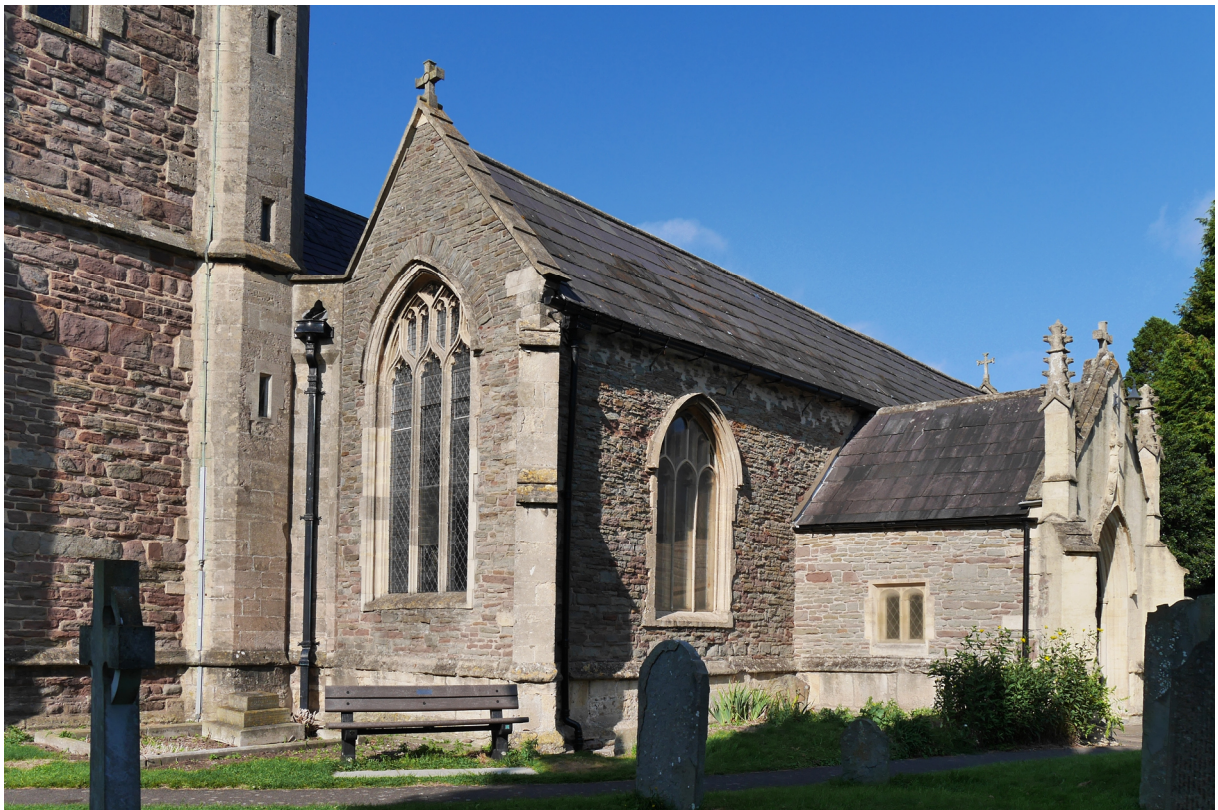
Glass fragments were found outside the two large windows at the western end of the south aisle (between the tower and south porch).

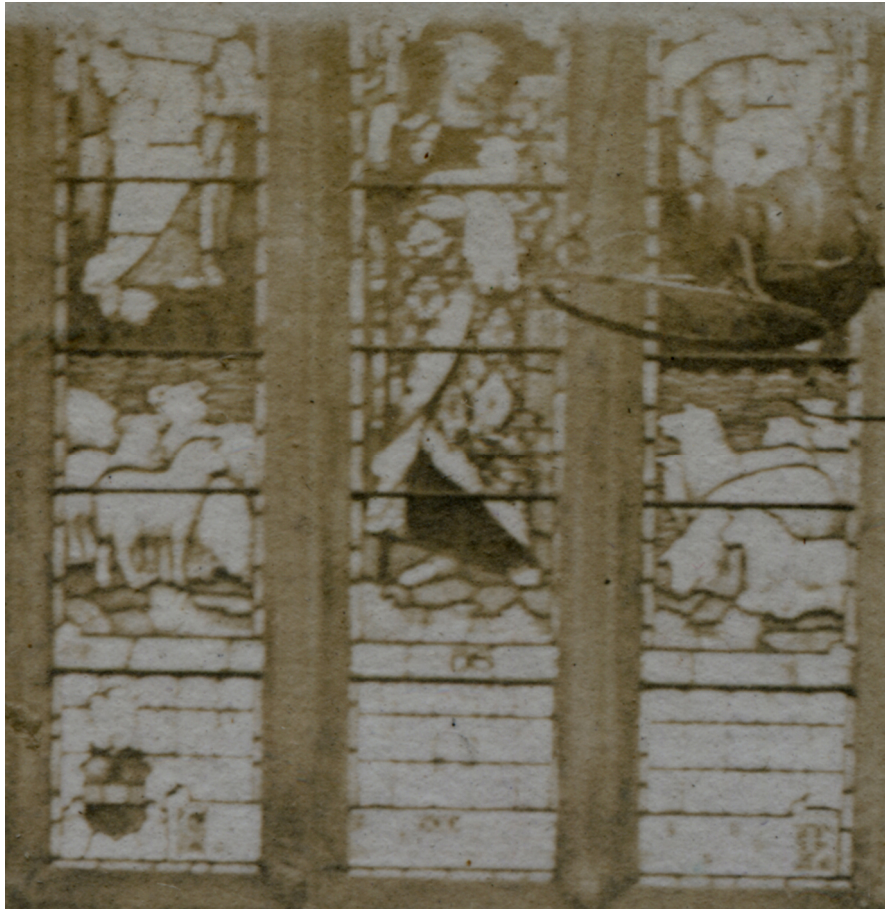
The lower part of the stained glass window on the south wall, between the porch and the west end (Winchester 1919b).

Winchester's photograph shows this as a pictorial window featuring a naturalistic flock of sheep in both side panels, with the central pane depicting a figure apparently holding a lamb (a representation of 'the good shepherd' perhaps).

Superficially at least, one shard (south side 2, page 9) resembles glass in the borders to the four angelic figures that have survived in the panels at the very top of this window (with dark parallel lines and golden 'silver stain').

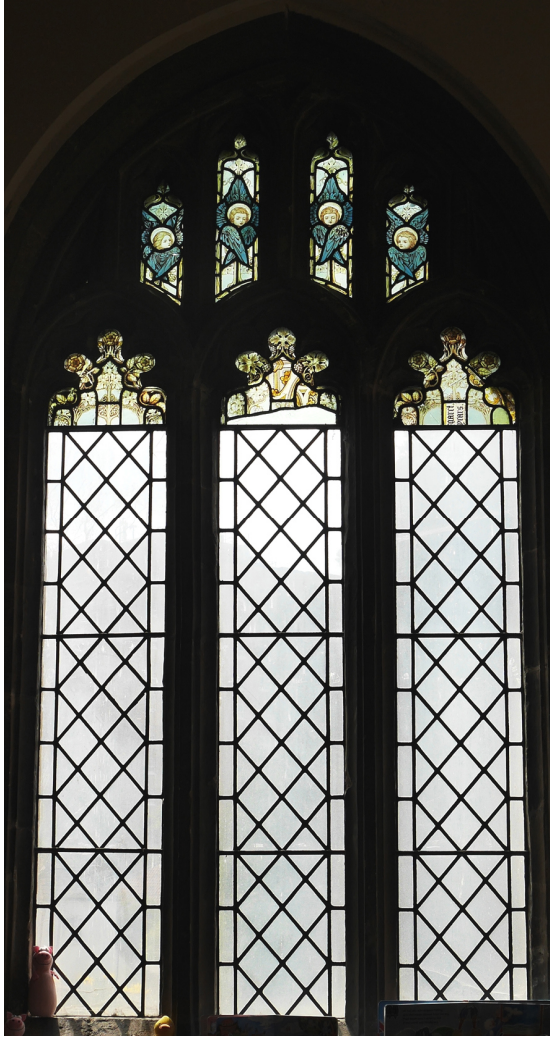
The present-day window on the south wall, between the porch and west end (interior).

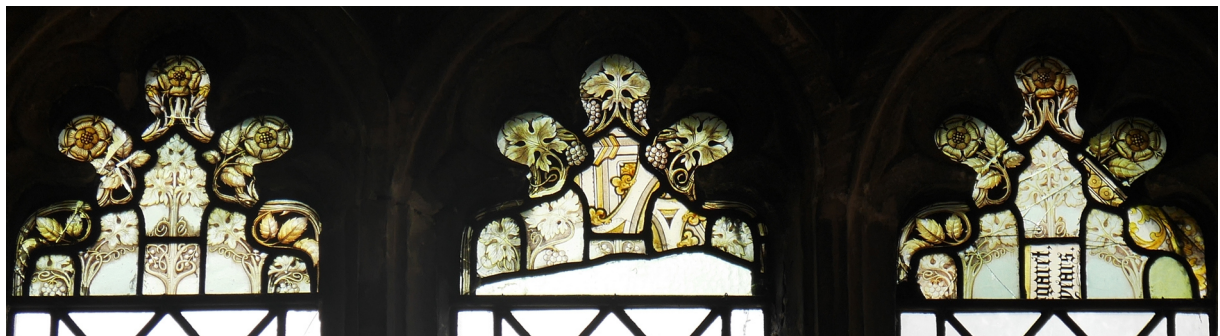
Detail of the window on the south wall between the porch and west end. These fragments of stained glass were salvaged from the window shattered by the WW2 bombing, carefully selected for suitability, and reused in this high part of the current window. The uppermost parts of the window depicting seraphim escaped blast damage, presumably because those panels had too small a surface area for the pressure wave to buckle and break them).

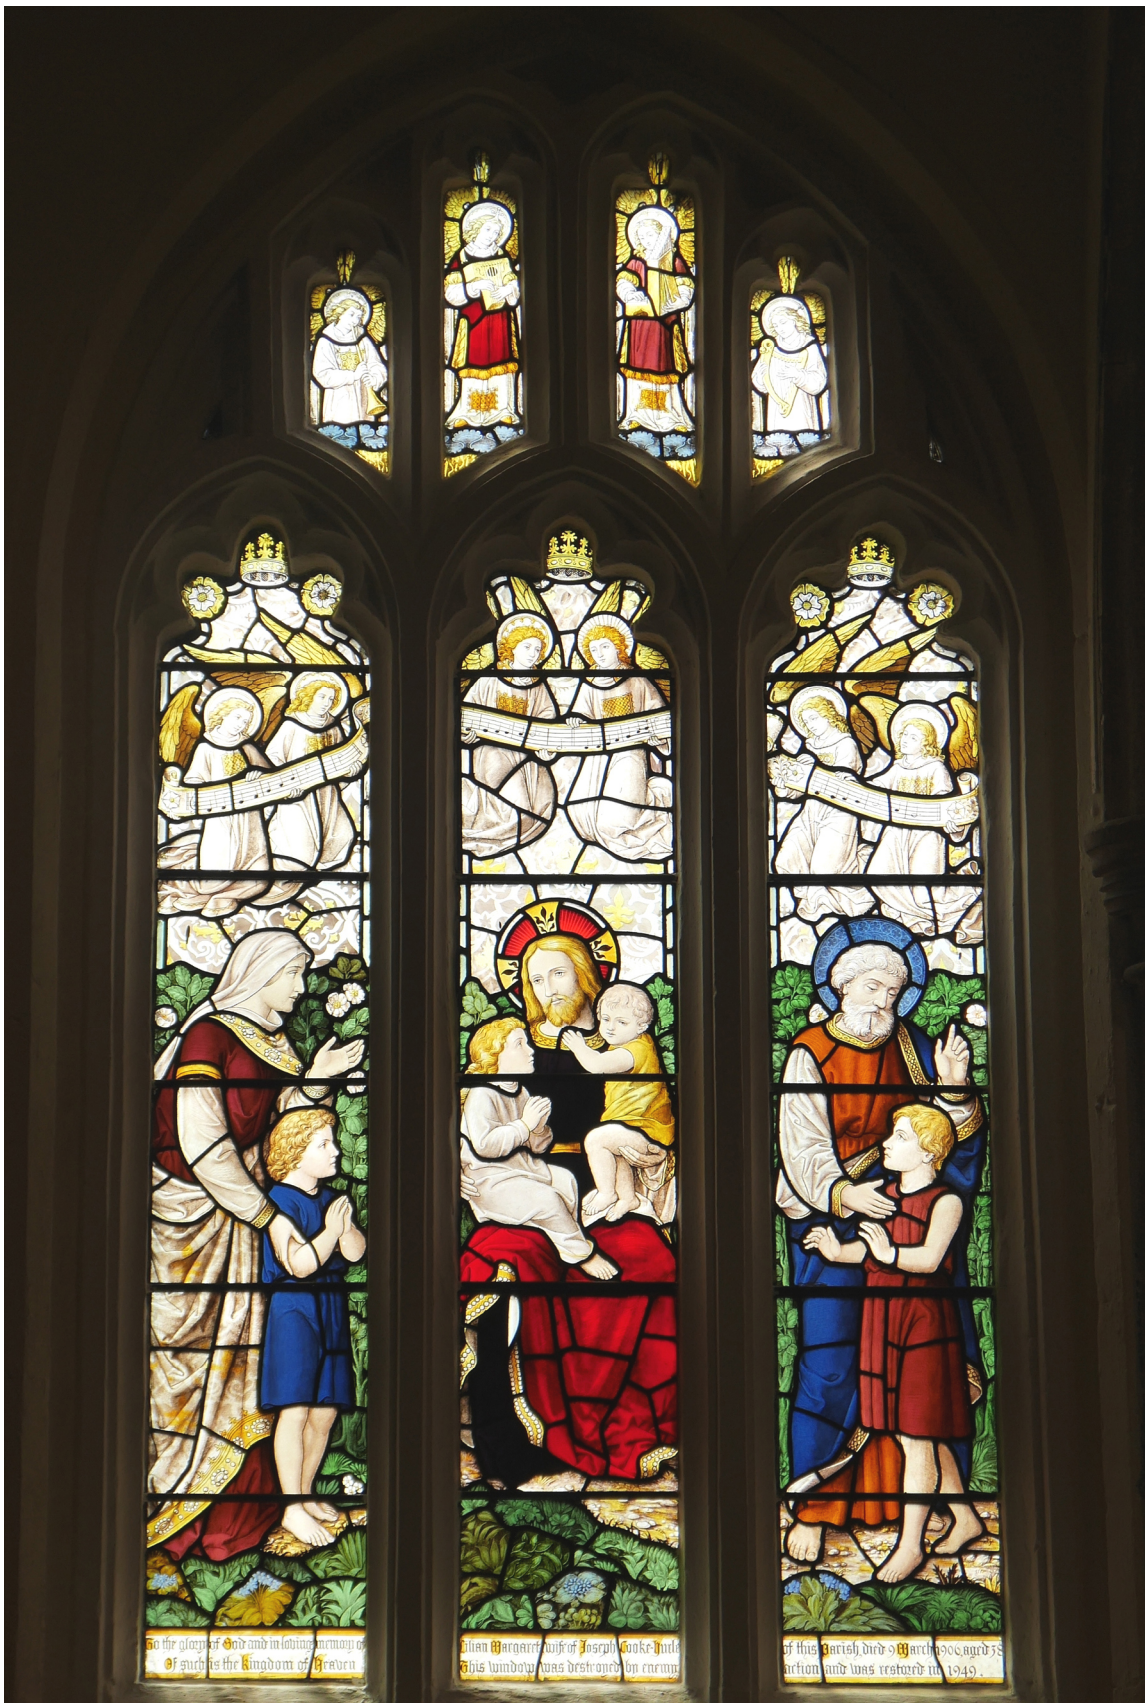
The 1908 Cooke-Hurle memorial restored in 1949 after WW2 bomb damage. The original work is attributed to Burlison & Grylls (Foyle & Pevsner 2011, 417).

The south wall of the south aisle has three windows. That in the Lady Chapel was erected in 1908 as a memorial to Lilian Cooke-Hurle, and features bars of music from her favourite hymn. It depicts the Biblical story where Jesus explained the kingdom of heaven belongs to those who are as children (Matthew 19, 13-15).

It bears the legend: 'This window was destroyed by enemy action and was restored in 1949.' The fragments of the window were salvaged by curate Reverend Shipley

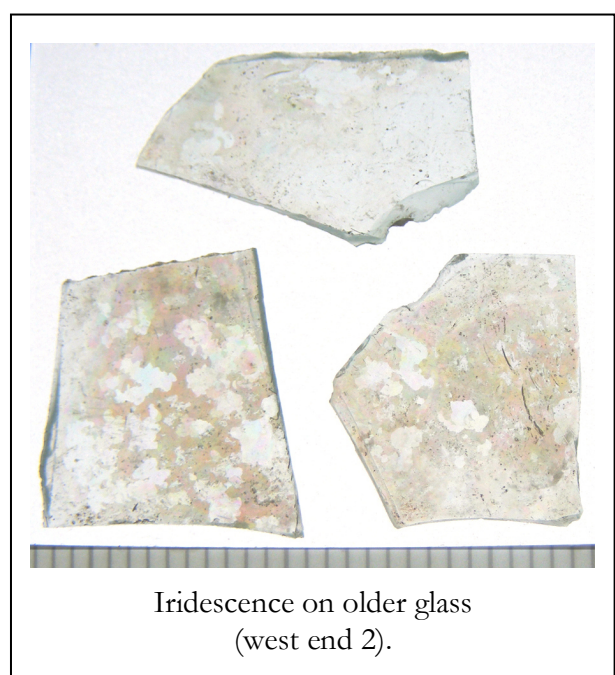
Pot metal glass  
(west end 3).

More prominent hues of single coloured glass are known as pot metal glass because the colour (in the form of metal salts) is added to the molten glass in its crucible or 'pot'. This process mixes the colour evenly throughout the glass.

Two shards, both containing minute bubbles that are a mixture of both spherical and oval (the long axis of the ovals being aligned with each other) and have faces covered in minute irregular undulations. One shard (west end 3, page 7) has one edge that is matt and smooth, unlike the usual glassy lustre of a broken edge - this is likely to be an original edge. This edge is on the left-hand side of the photograph.

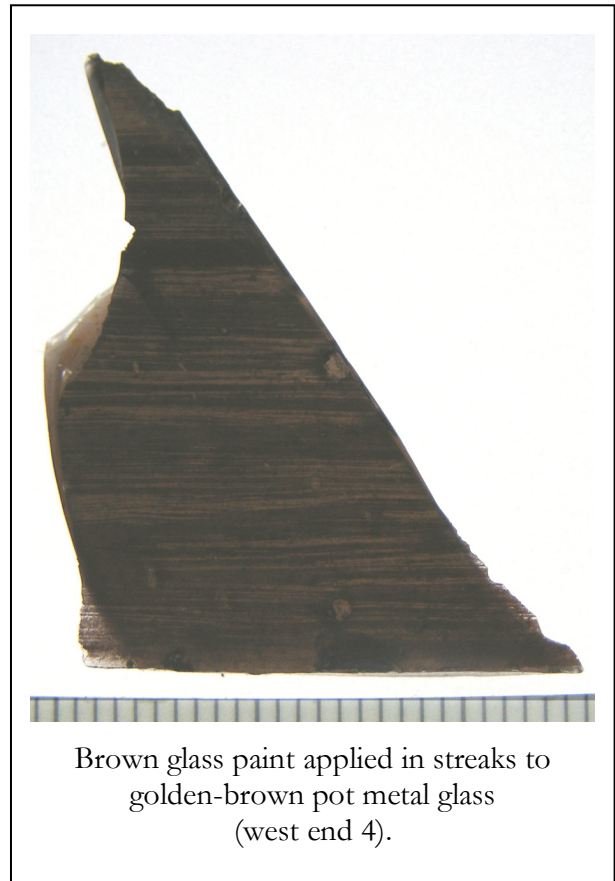
Brown glass paint applied in streaks to  
golden-brown pot metal glass  
(west end 4).

This shard has one face covered with thin brown paint in numerous narrow streaks such that until it's held to a light source it appears opaque. There are numerous spherical and oval bubbles. This is pot metal glass with a golden-brown colour throughout (west end 4, page 7).

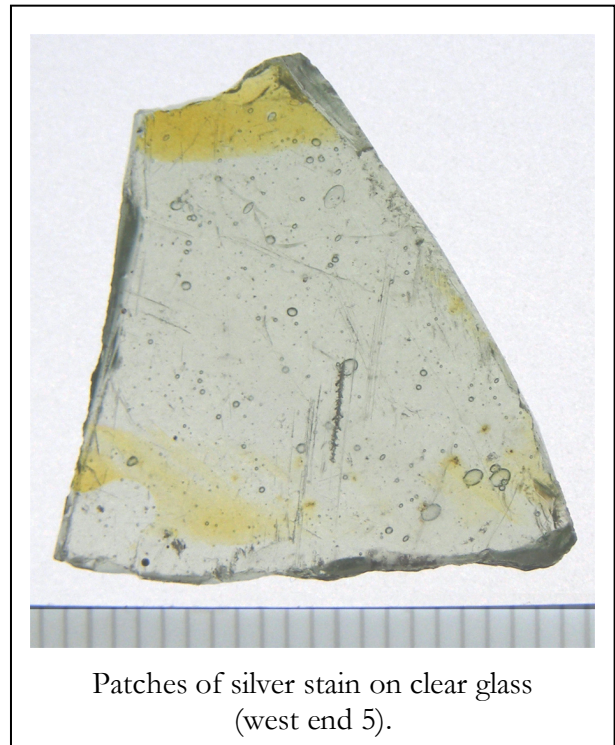
Patches of silver stain on clear glass  
(west end 5).

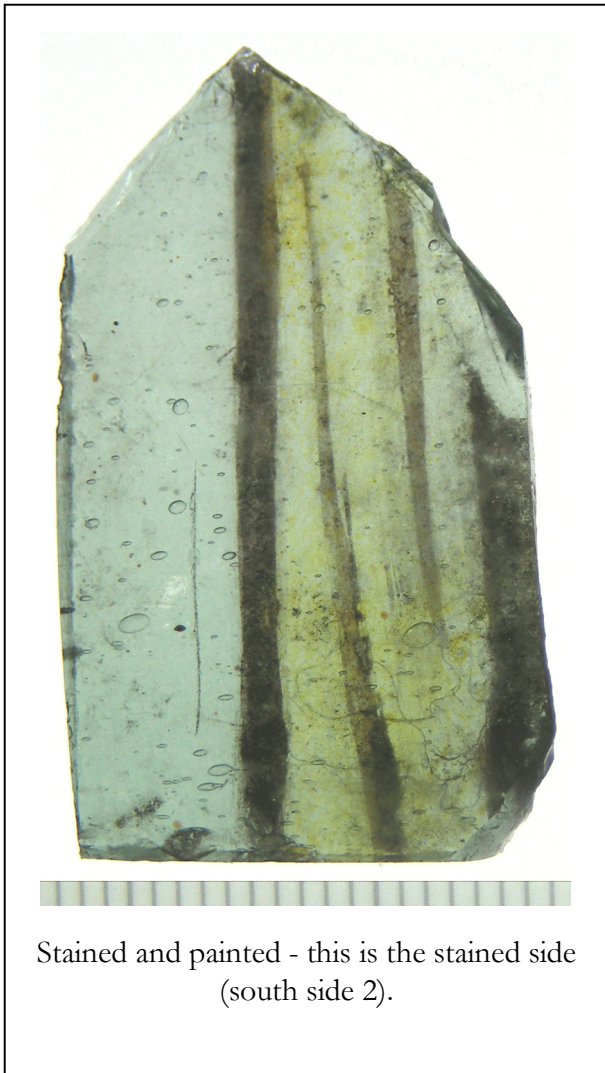
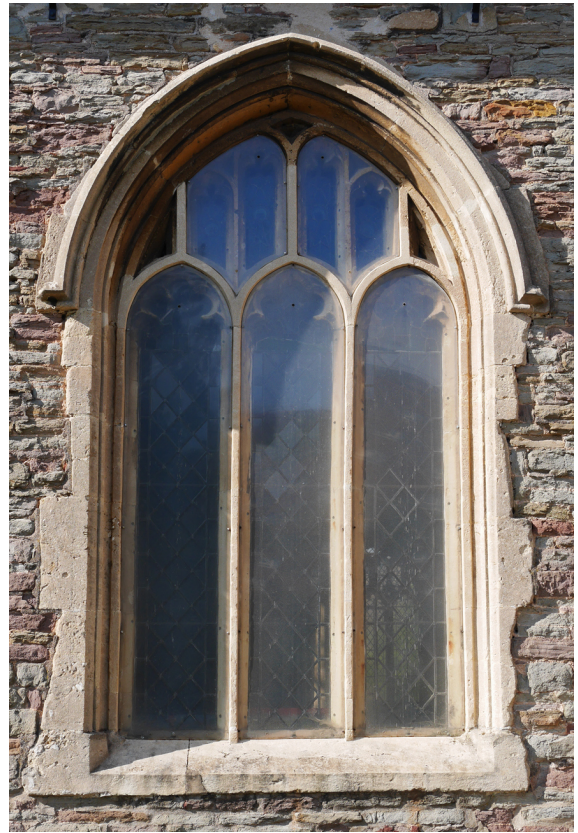
Ten shards of glass were found on the south side of the south aisle, to the west of the south porch.

South side of the south aisle, west of the porch (exterior).

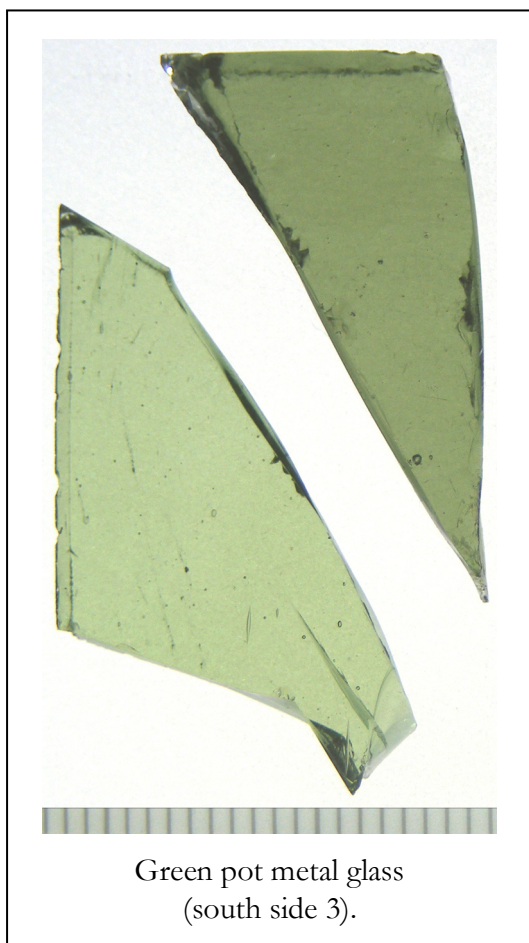
The original edge appears to have been milled flat, and all along the length of this edge are arced striations that aren't quite perpendicular from flat side to flat side. The arcs are in a roughly parallel series, spaced at an average of approximately two per millimetre.

Curved striations from grinding the edge flat - this is the edge closest to the scale at the bottom of the adjacent photograph (south side 2).

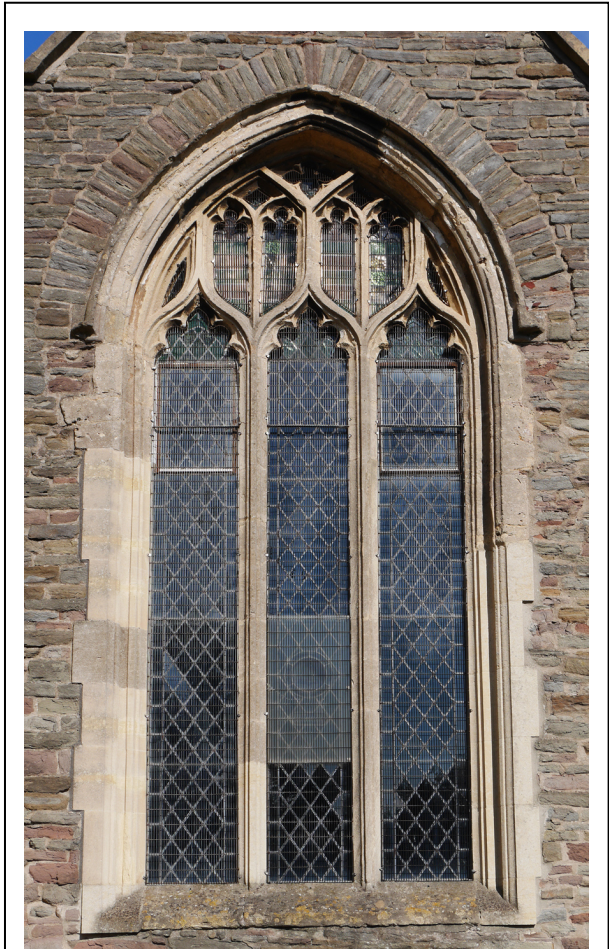
Twenty-seven shards of glass and a piece of window lead were found at the west end of the south aisle.

West end of the south aisle (exterior).

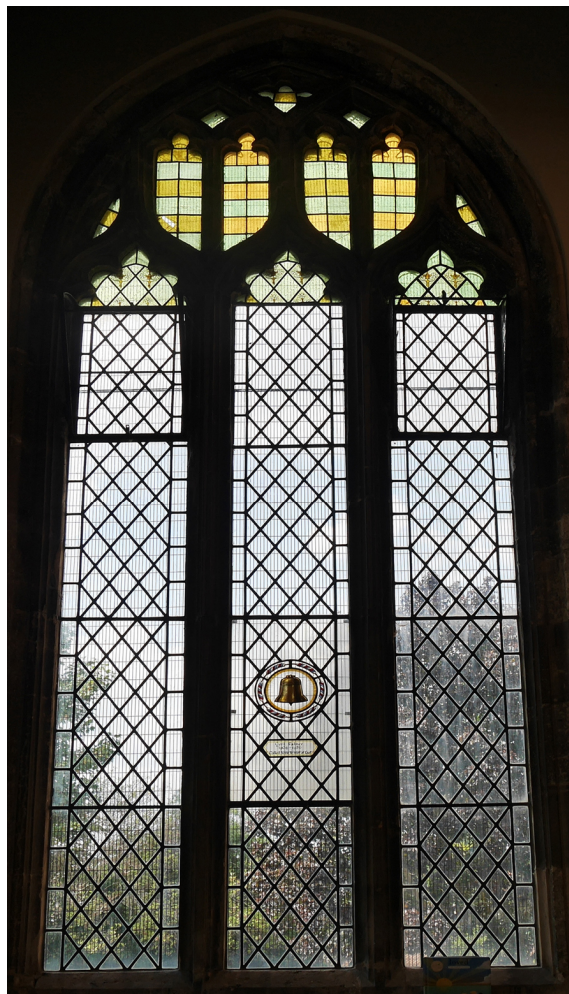
West end of the south aisle (interior).

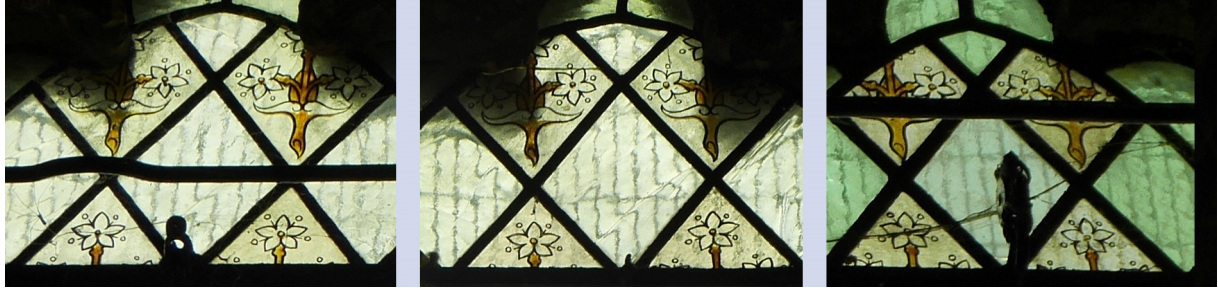
Detail of three of the upper sections of the window at the west end of the south aisle showing the surviving floral patterns that once filled the window (it would be very interesting to know the date of these charming motifs).

The floral pattern has a straight stem rising to a single pair of opposed leaves surmounted by a central bulge from which three short stems emerge, each of which culminates in a flower with five petals. The flower is surrounded by four small dots, each associated with one of the four gaps between the petals.

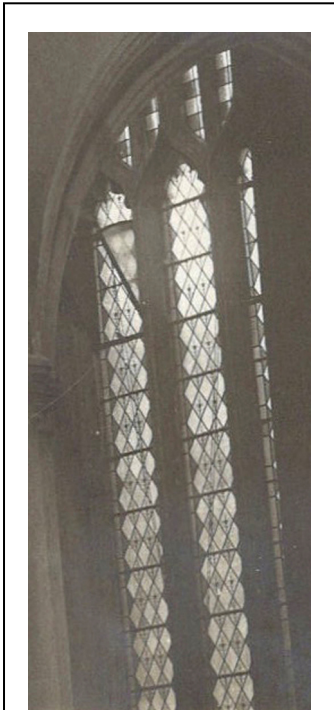
The upper part of the west window of the south aisle (Winchester 1919a).

Winchester's photograph shows this window to be very different from the pastoral scene displayed in the window on the south side. Here, at the top of the lights we find stripes of alternating green and yellow (greenish) rectangles, and diamond-shaped panes below. The latter are either unadorned or contain a floral motif used throughout the window.

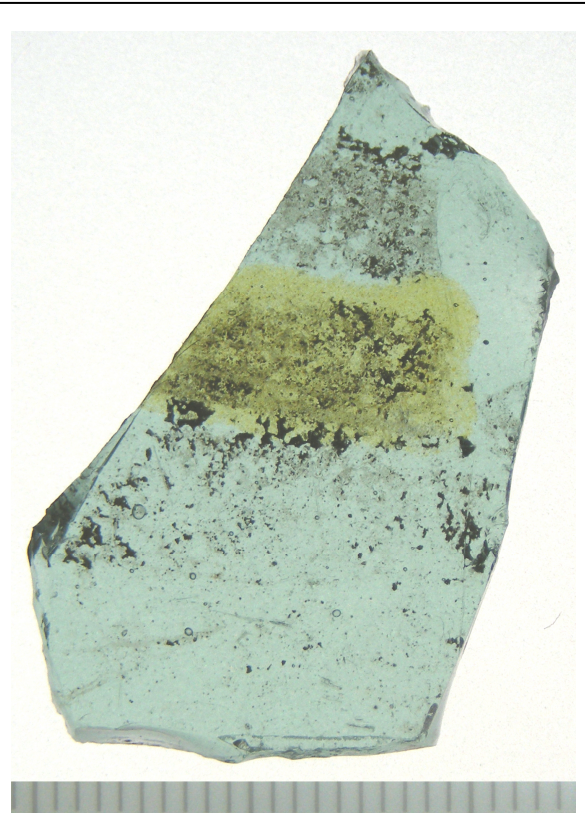
This shard has a patch of transparent yellow silver stain on a polished face covered with small dimples. There are a dozen or so small bubbles: almost all are spherical.

Blue pot metal glass with silver stain (west end 7).

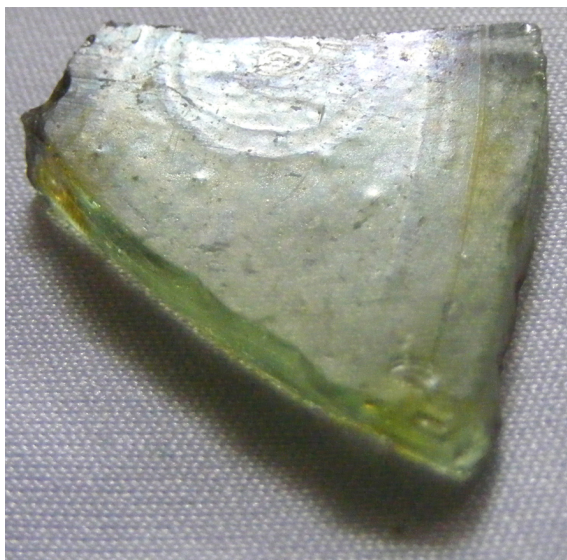
The other shard (west end 8, below) has two parallel curving lines - probably a segment of a circle very approximately 600mm (24 inches) in diameter. The gap between those lines is 13mm (0.5 inch) and evenly spaced in that gap is a circle 10mm (0.41 inch) in diameter, containing two or more concentric circles.

This shard reduces steadily in thickness over the course of 22mm from 3.8mm to 2.2mm (58%), and has numerous bubbles, with approximately equal numbers of spherical and oval shapes (the latter all being aligned in the same direction).

Features perhaps analogous to watermarks  
(west end 8).

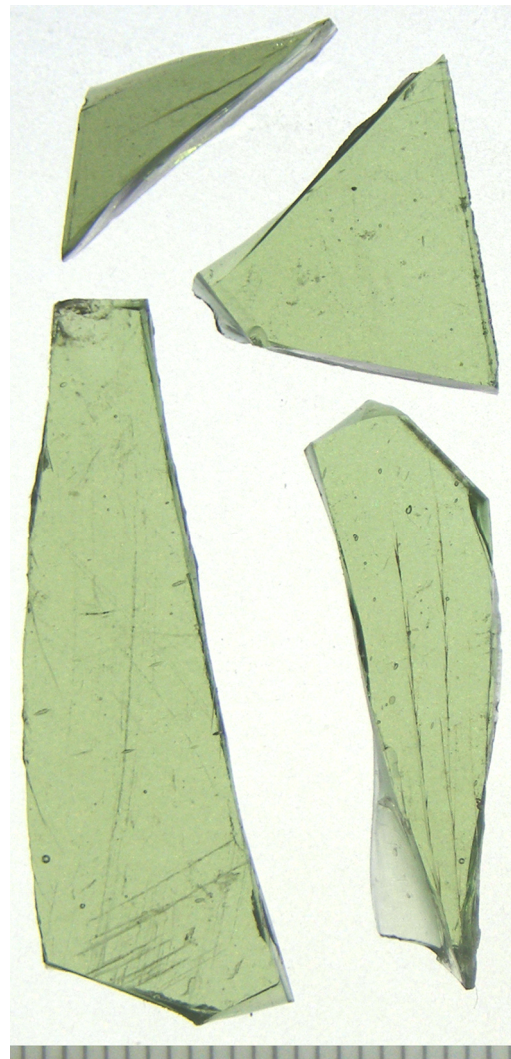
Four shards of pot metal glass: one shard (upper right, west end 9) has one face covered in minute irregular undulations. The other three shards have minute parallel striations covering one face and each has at least half-a-dozen bubbles.

Green pot metal glass  
(west end 9).

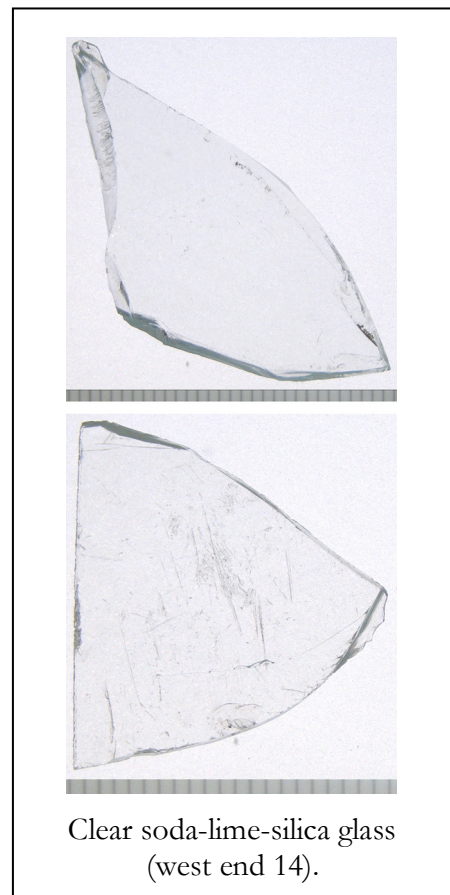
Two shards of soda-lime-silica glass (made after the 1820s). The upper shard (west end 14) has one face covered in minute parallel striations, while the other face is covered in minute irregular undulations.

The other shard has one straight edge. On the angle where this edge meets a surface, is a line of tiny indentations.

The row of minute flake-scars appears to be consistent with those that might be made by a cutting tool drawing a linear incision to create a weakness along which the glass should break when stressed.

The width of the line is approximately one tenth the thickness of the glass, so the scored line would have been around 0.2mm deep.

The presence of clear (soda-lime-silica) glass and the brown painted shard are anomalies that seem best to be explained as contamination from another window destroyed by bomb blast.

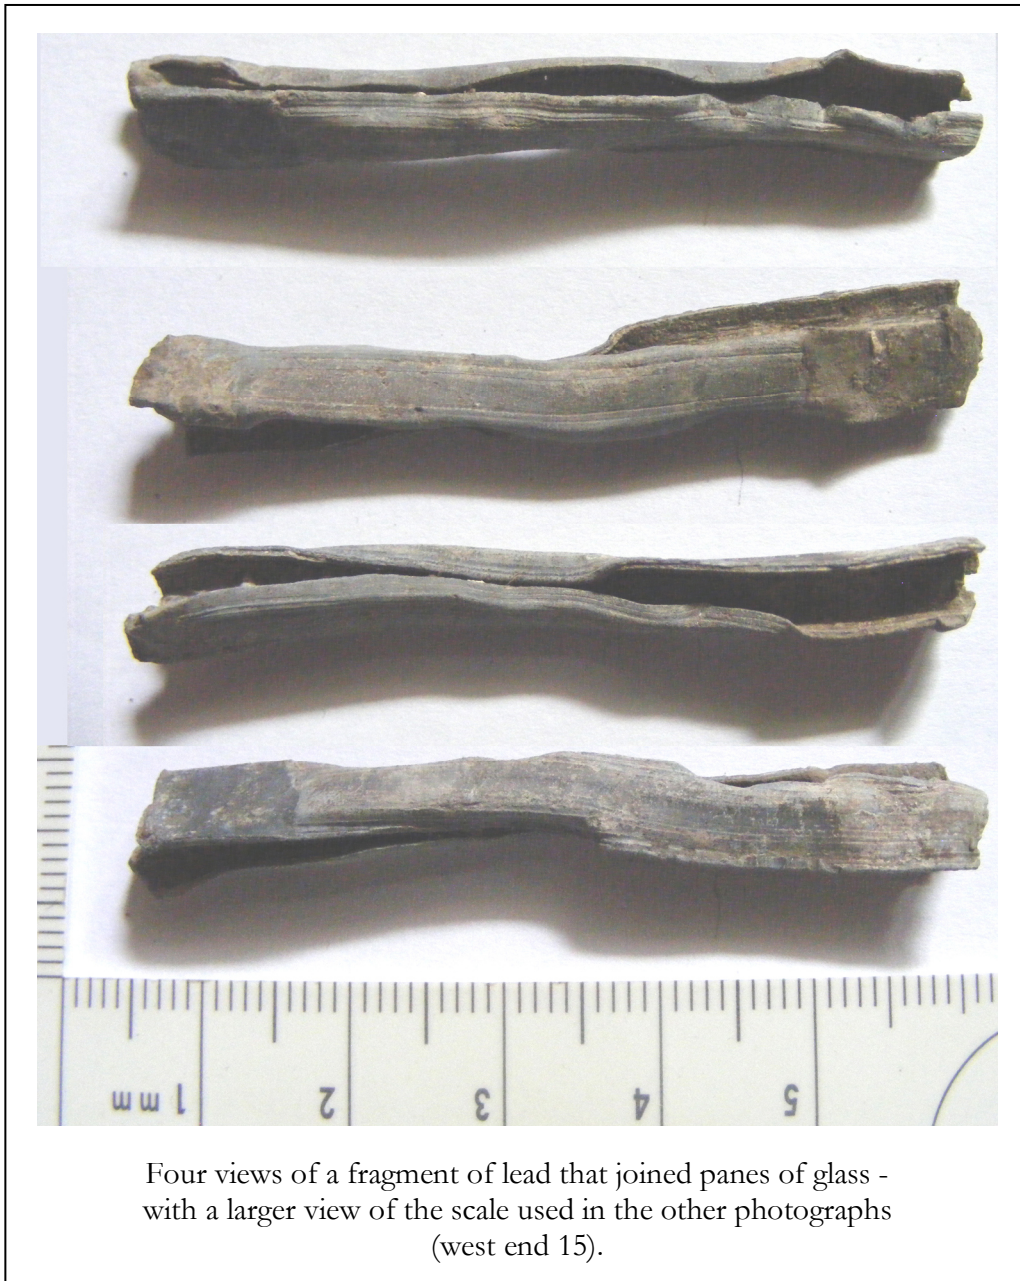
A single strip of specialist window lead known as a came (or calm) was found. It has a cross-section in the shape of the letter I, which means it was designed to accommodate one sheet of glass on each side.

It's 57mm long, 6.4mm wide, and weighs 8g. The 'I' is 5.1mm high and has an internal gap of 3.3mm, which indicates the intended thickness of the glass (lead is malleable though, providing some flexibility for varying thicknesses of glass).

Four views of a fragment of lead that joined panes of glass - with a larger view of the scale used in the other photographs (west end 15).

Most shards may be interpreted as being from the window in Winchester's photograph. The pot metal of green and of yellow (greenish) are probably identical to the stripes at the top (a two-tone pattern bordered the floral panels). And the very pale blue-green shards could be from the unadorned diamond panes. Even the strip of lead could be from this window.
